PHOTOGRAPHIC INTERPRETATION BRIEF

MARHWI-RI ARMY BARRACKS, NORTH KOREA

NPIC/R-1488/63

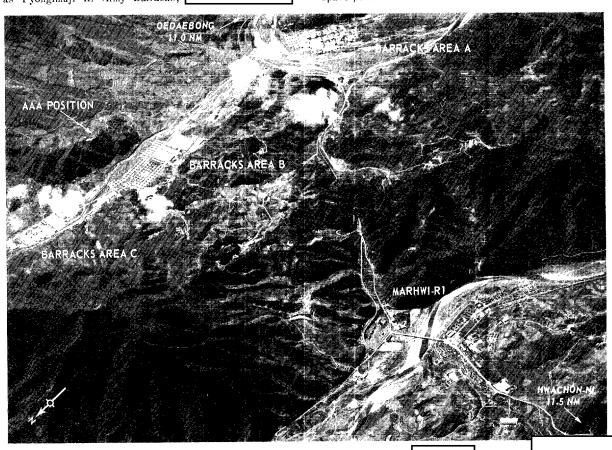
FIGURE 1. MARHWI-RI ARMY BARRACKS, NORTH KOREA

The Marhwi-ri Army Barracks (Figure 1), situated 1.3 nm east of Marhwi-ri and approximately 220 acres in area, comprises 3 separate road-served areas.*

Barracks Area A contains 19 quarters-type buildings (30 x 20 ft), 12 barracks (85 x 30 ft), 15 support buildings (ranging in size from 45 x 15 ft to 85 x 35 ft and totaling 20,000 sq ft

of floor space), and 3 L-shaped administration/ support buildings (totaling 11,850 sq ft of floor space). Area A has a capacity of 1,050 troops.**

Barracks Area B, situated north of Area A and probably associated with Areas A and C as a dependents housing and storage area, contains one large multistory C-shaped administration, one small C-shaped administration, **Troop capacity is based on a figure of 40 sq ft of floor space per man.

and one other administration building, 84 quarters-type buildings (30 x 20 ft), 9 storage buildings (120 x 20 ft and totaling 21,600 sq ft of floor space), and 21 support buildings (ranging in size from 20×20 ft to 215×35 ft and totaling 36,300 sq ft of floor space). A 4-gun, in-line, probably occupied, light AAA position is situated on a ridge line immediately east of Area B.

Barracks Area C, situated north of Area B, contains 6 barracks (85 x 30 ft), 3 barracks

(45 x 30 ft), 3 a ministration buildings, one reverse-F-shaped administration/support building (totaling approximately 8,100 sq ft of floor space), one possible theater, and 18 support buildings (ranging in size from 40 x 20 ft to 105 x 35 ft and totaling 29,000 sq ft of floor space). Area C has a capacity of 485 troops.*

Approximately 25 vehicles were observed throughout the barracks area.
